ACCELERATED ARTIFICIAL CORROSION MONITORING OF REINFORCED CONCRETE SLABS USING THE HALF-CELL POTENTIAL METHOD

Justin Wilson, University of Massachusetts Lowell, Lowell, MA

Tzuyang Yu, University of Massachusetts Lowell, Lowell, MA

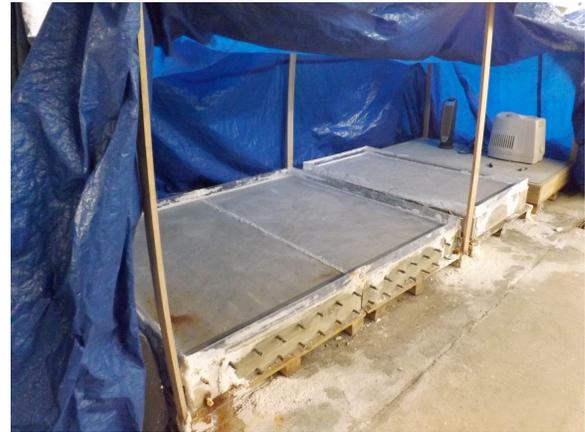
Fig. 2 Four slabs inside a plastic tarp

The saline concentration (15%), relative humidity (50%), and temperature (100°F in drying, 73°F in ponding) were kept constant to create a controlled environment for accelerated corrosion. HCP measurements were taken at the end of the drying period. Climate control (temperature and relative humidity) was achieved using two heaters and a humidifier placed under a plastic tarp. The tarp was suspended from six wooden posts attached to a wooded base of the slabs. Temperature and relative humidity were monitored throughout the experiment using two wireless thermo-humidity sensors at a sampling rate of 15 minutes. Fig. 2 shows the plastic tarp and the RC slabs in the Concrete Laboratory at UML.

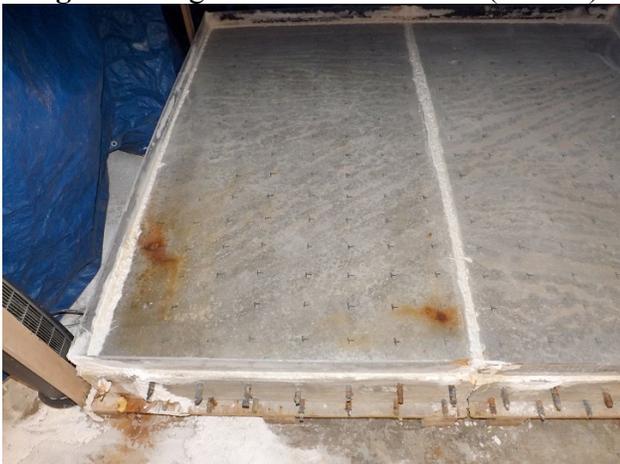
Fig. 4 Surface rust locations on slab 1

Time-dependent average and minimum HCP curves of all four RC slabs are provided in Fig. 3. In Fig. 3, it is observed that the slab 4 HCP curve is well above -350 mV, indicating no corrosion activities inside the slab. Until the fifty-second week of the experiment, based on the average HCP measurements collected from all RC slabs, slab 1 shows most severe corrosion (average HCP lower than -380 mV), while slab 2 and 3 shows an average HCP around -140 mV and -240 mV, respectively. This result is evident and in good agreement with visual inspection. Fig. 4 shows two major locations on slab 1 with spreading rust on the surface of slab 1. Fig. 5 is the close-up of the rust location on the left of

Regarding the spatial distribution of HCP measurements, contour maps of HCP data at week 52 were generated. Figs. 12~15 show the HCP contour of all slabs. In Fig. 12, high corrosion activities are found at the lower edges of the slab. This is in good agreement with the visual images on slab 1 (Fig. 4). Comparing Fig.

- Comparing measured HCP data with visual inspection on the slabs, spreading surface rusts were found at the locations with very low HCP values (<-500mV) (Figs. 4 and 12). This observation will be used to predict the onset of surface rust on the slabs in the future.
- Although the quality of concrete was carefully controlled, from the HCP data collected on unponded slab 4, certain level of fluctuation was observed in the HCP data. This information can be used to indicate the level of HCP background noise and used to de-noise HCP data.

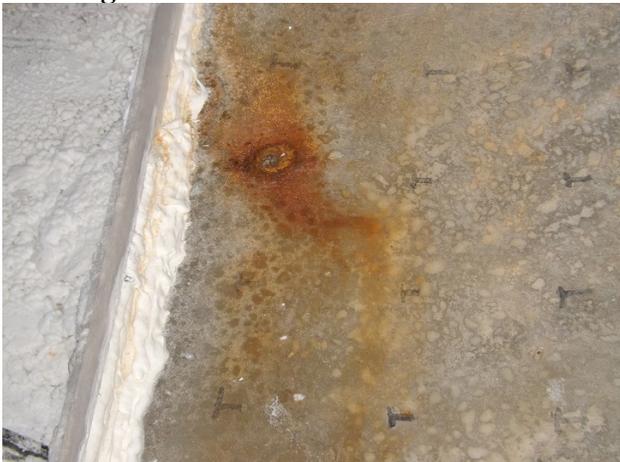
Fig. 5 Close-up surface rust location on the left of slab 1

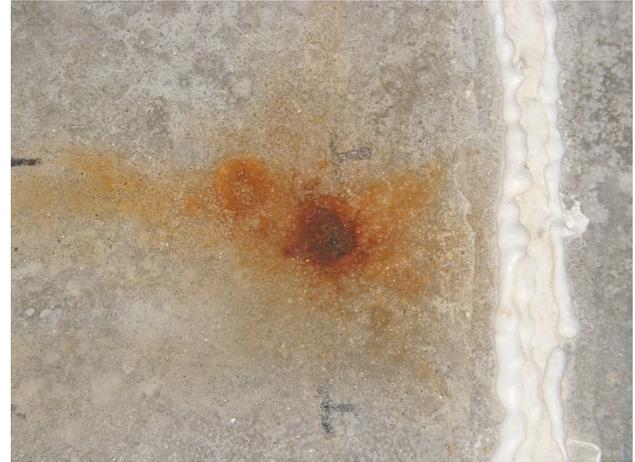
Fig. 6 Close-up surface rust location on the lower right of slab 1

slab 1, while Fig. 6 is the close-up of the rust location on the lower right of slab 1.
