Article

All-Optical Photoacoustic Sensors for Steel Rebar Corrosion Monitoring

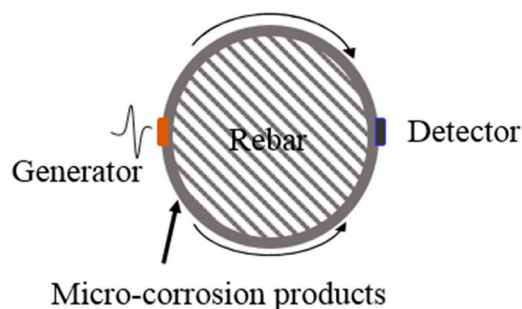
As shown in Figure 1, the ultrasound generator and detector were attached on opposite sides of steel rebar. The ultrasound waves, excited by the ultrasound generator, propagated on the surface of steel rebar. Opposite of the generator, the ultrasound detector was employed to detect the signals from steel rebar. The irregularities' microstructure changes in the steel rebar profile surface can respond once the transmission ultrasound waves impinge the ultrasound detector.

Figure 1. The principle of ultrasound corrosion monitoring.

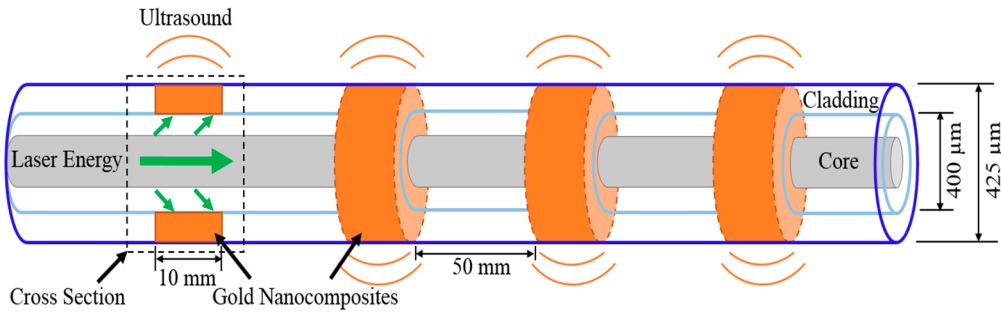
The distributed photoacoustic sensor was based on evanescent wave to be fabricated on the sidewall structure of 400/425 μm core/cladding multimode fiber (MMF). As shown in Figure 2, the MMF was stripped, cladding at a length of 10 mm, to form the sidewall structures and the distance between sidewall structures was 50 mm. In this study, four sidewall structures were made in total. The structure of ultrasound generators was designed to attach to the steel rebar by coating gold nanocomposite on the core of sidewall structures.

Figure 2. The schematic of distributed photoacoustic sensor.

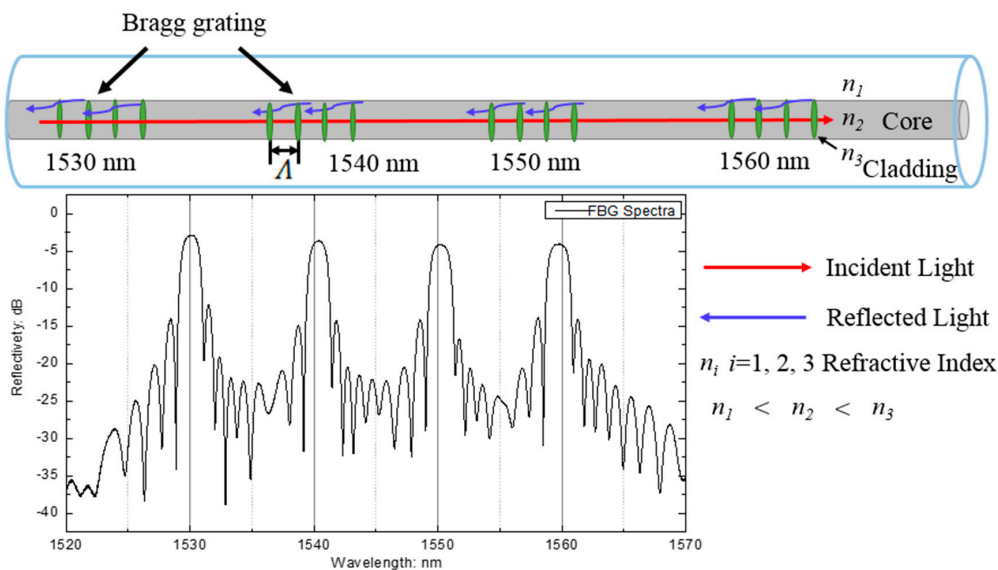
where n_e and Λ are the effective refractive index of the fiber core and the grating period, respectively. The ultrasound detector part of our system was built based on the wavelength-division multiplexing techniques, as shown in Figure 3. The four FBGs were multiplexed in a single mode fiber. The central spectra are 1530 nm, 1540 nm, 1550 nm, and 1560 nm, respectively. Because of the continuous-wave mode of FBG sensor array, the wavelength of each sensor does not overlap and requires occupation of a distinct wavelength window [23].

Figure 3. Optical reflection spectrum of the wavelength-division multiplexing techniques.

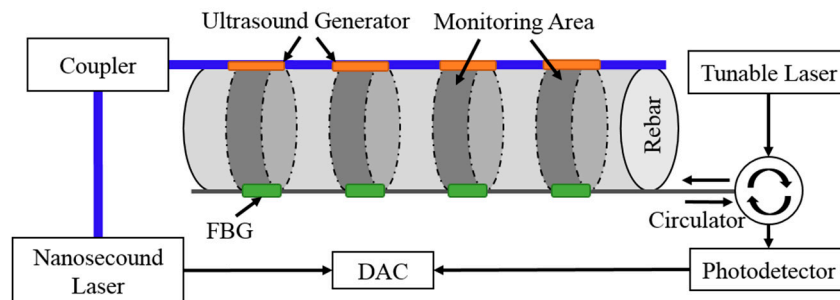
The schematic diagram of all-optical ultrasound corrosion sensing system is shown in Figure 4. The pulsed laser, emitted by nanosecond laser (Surelite-I-10, Continuum, San Jose, CA, USA), was coupled into MMF (UM22-400, Thorlabs, Newton, NJ, USA). The nanosecond laser source was Nd:YAG laser with 10 Hz repetition rate and 6 ns pulse-width. The laser energy was 200 mJ. The pulsed laser shot the gold nanocomposite attached on the side wall of MMF to generate the ultrasound waves. The ultrasound waves transmitted directly along the circumstantial surface of rebar to the FBG detectors.

Figure 4. Setup of distributed ultrasound corrosion monitoring.

To localize the corrosion position and degree, the FBG sensors were modulated by means of light intensity demodulation in four different wavelengths by using a tunable laser (Venturi TM Tunable Laser, TLB-6600, Santa Clara, CA, USA) as a probe light [9]. As the ultrasound vibration impinged the FBG sensors, the shifts of the central spectrum reflected to the photodetector via a circulator. The photodetector (PDA10CS, Thorlabs), with correspondence to the ultrasound signal power, could transfer the light signal to voltage magnitude. Finally, the data acquisition card (DAC) embedded in the computer recorded the voltage signals.

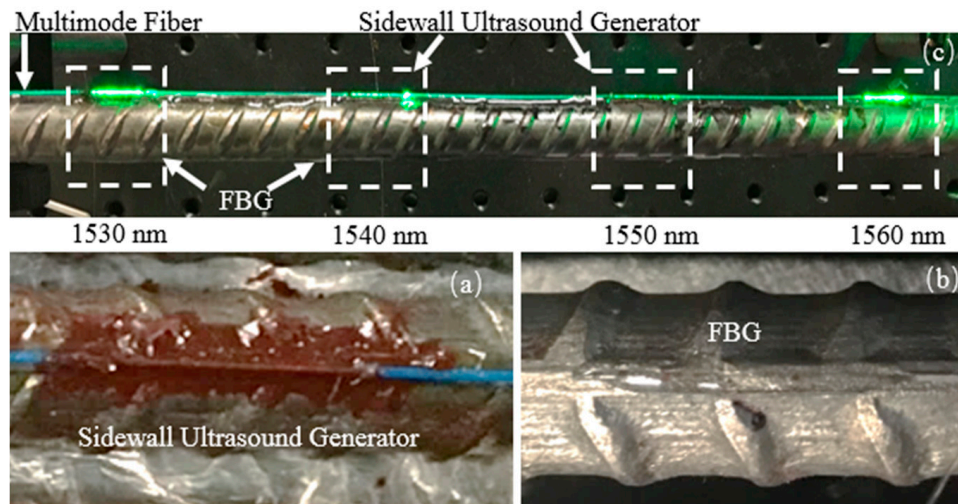
Before preparation for the generator and detector, the steel rebar was cleaned with acetone. There were four steps for fabrication of the distributed photoacoustic sensor on the steel rebar: (1) The four 10 mm length cladding on the MMF were removed to expose the core; (2) the MMF was bound by tape along the rib of the steel rebar, and four cores were kept in the middle position of the rib of the steel rebar; (3) gold nanocomposites were coated on the cores, attaching on the rib of the steel rebar to form the sidewall ultrasound generators; (4) the ultrasound generators were cured for 3 days on a hot plate at 120 °C. On the opposite of the generator, the epoxy (Gorilla) was then used for fixing the FBG (FBG length: 1 mm, CW: 1550 ± 0.5 nm, FWHM: 1.5 ± 0.2 nm) detector along the rib of rebar [6]. Finally, an ultraviolet glue (365A, Agiltron, Woburn, MA, USA) was covered on the fibers for protection. The entire all-optical photoacoustic sensors are shown in Figure 5c.

Figure 5. The fiber photoacoustic sensors. (a) The photo of the sidewall photoacoustic (PA) ultrasound generators attached on a rebar. (b) The photo of the fiber Bragg grating (FBG) detectors attached on a rebar. (c) The position of distributed photoacoustic sensors.

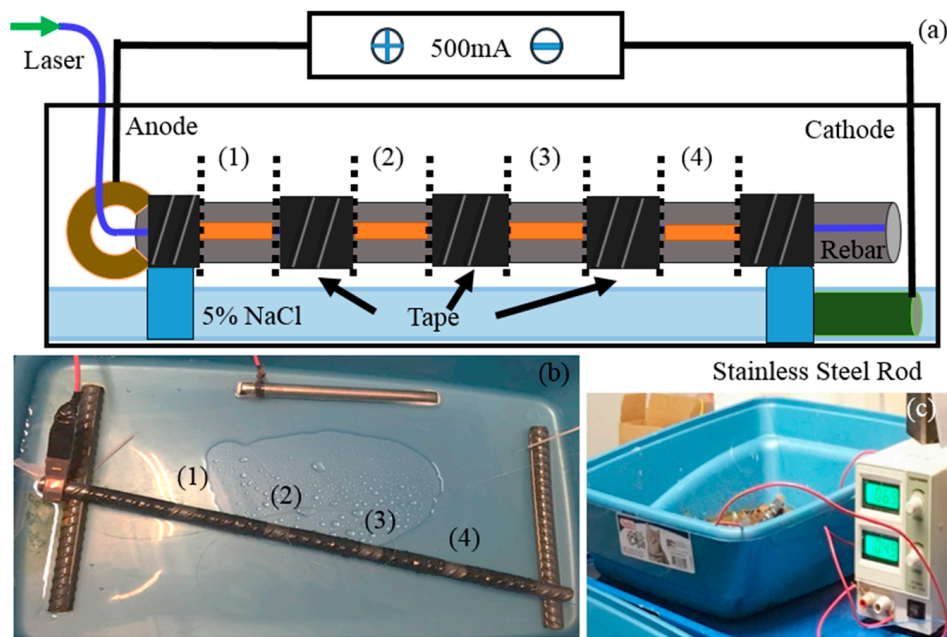
To monitor different levels of corrosion on a single steel rebar using a sensing system, an accelerated corrosion test (ACT) setup was applied in Figure 6. The No. 4 steel rebar was covered with electrical insulation tape leaving only four 10 mm sections and the two ends exposed. The specimen was then suspended in a plastic container and connected to a power supply, which impressed a constant current of 500 mA. A 5% (by mass) sodium chloride (NaCl) solution was sprayed onto the specimens at an interval of 24 h. At each 24 h interval, the specimen was rotated at an angle of 180° to ensure uniform corrosion level. The steel rebar served as the anode and a 12.7 mm diameter stainless-steel rod served as the cathode.

Figure 6. The experimental setup of corrosion monitoring on steel rebar specimen. (a) Schematic of accelerated corrosion test (ACT) setup. (b) Four spraying sections of steel rebar specimen. (c) Keeping a constant current of 500 mA.

To achieve four different corrosion levels on the single steel rebar, the four exposed sections marked (1), (2), (3), and (4), excluding the two ends on the steel rebar, were sprayed with 5% NaCl solution at different frequencies, shown in Table 2. The accelerated corrosion scheme was designed to ensure that rust products were bonded to the surface of the steel rebar at the end of the corrosion process.

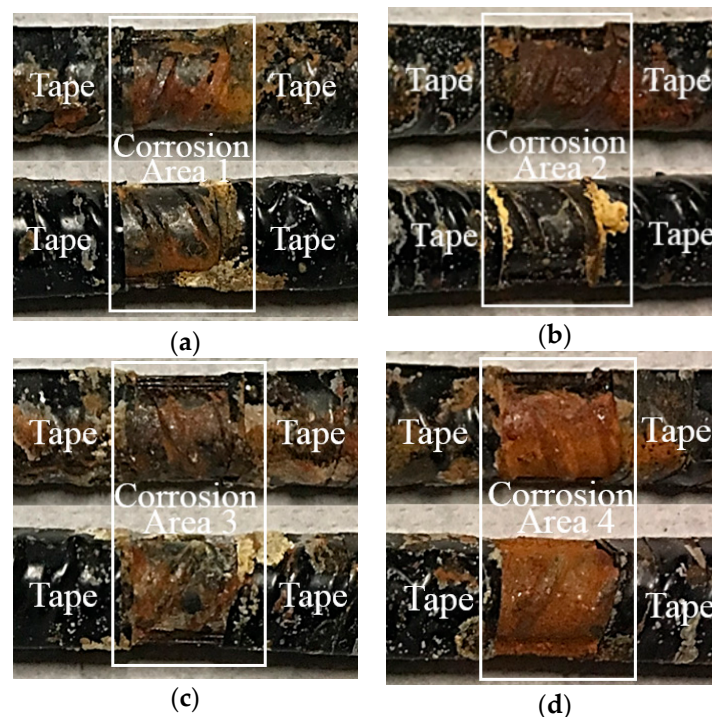
The experiments were kept in a temperature-controlled environment (temperature 25 °C) to prevent a cross-sensitivity issue between strain and temperature. According to the electrochemical principle on steel rebar corrosion, the corrosion rate corresponds to the accelerated corrosion testing time. Corrosion section (1) exhibited the lowest corrosion rate and (4) exhibited the highest corrosion rate. As in Figure 7, the corrosion degree can be recognized via the surface profile of rebar. The rust products as the mass loss were measured and are listed in Table 3.

Figure 7. The photo assessment of the four corrosion locations with different corrosion rates. (a), (b), (c), (d) Represents the corrosion at area 1, 2, 3, 4 respectively.

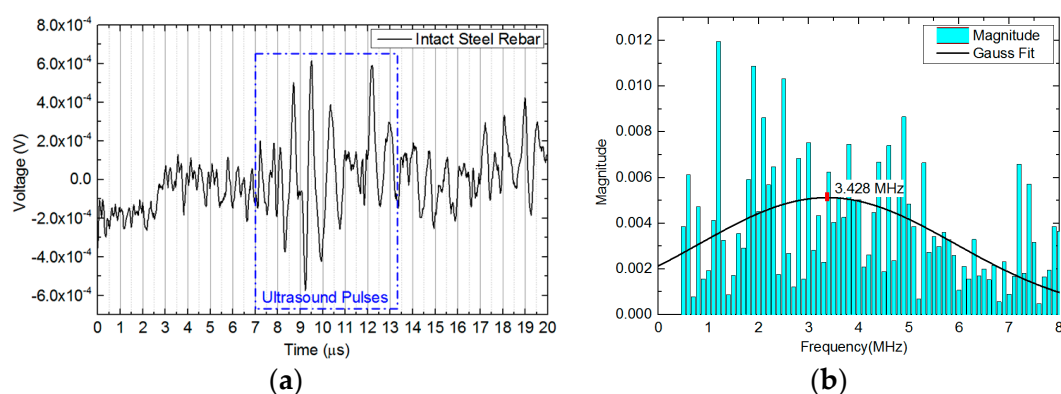
The time domain responses of ultrasound signals detected by FBGs on intact steel rebar are shown in Figure 8a. The signals were averaged 100 times. The fly time of the DAC was applied for around 20 μ s. Just as theoretically calculated in Section 2.1 above, the ultrasound pulsing began at 7 μ s and ended at 13 μ s. At the beginning of the trigger signal, the high-density signal jump was presented as a time domain response. That was from the low-frequency noise and electromagnetic interference between the channels of trigger signal and of received signal on the DAC.

In order to analyze the spectral responses of the steel rebar, the ultrasound signals were transformed into frequency spectra via fast Fourier transformation (FFT) in Figure 8b. The central frequency in detected sections were located by using a Gaussian fit. Before the ACT processes, the bandwidth of transmitted ultrasound signals of the intact rebar was under 8 MHz and the central frequency was 3.428 MHz. The frequency spectrum of the intact rebar was selected as baseline to assess the corrosion degrees.

Figure 8. The ultrasound signals detected by FBGs on intact steel rebar. (a) The time domain responses of ultrasound pulses; (b) the frequency domain responses of ultrasound signals and Gaussian fit on frequency spectrum to obtain central frequency.

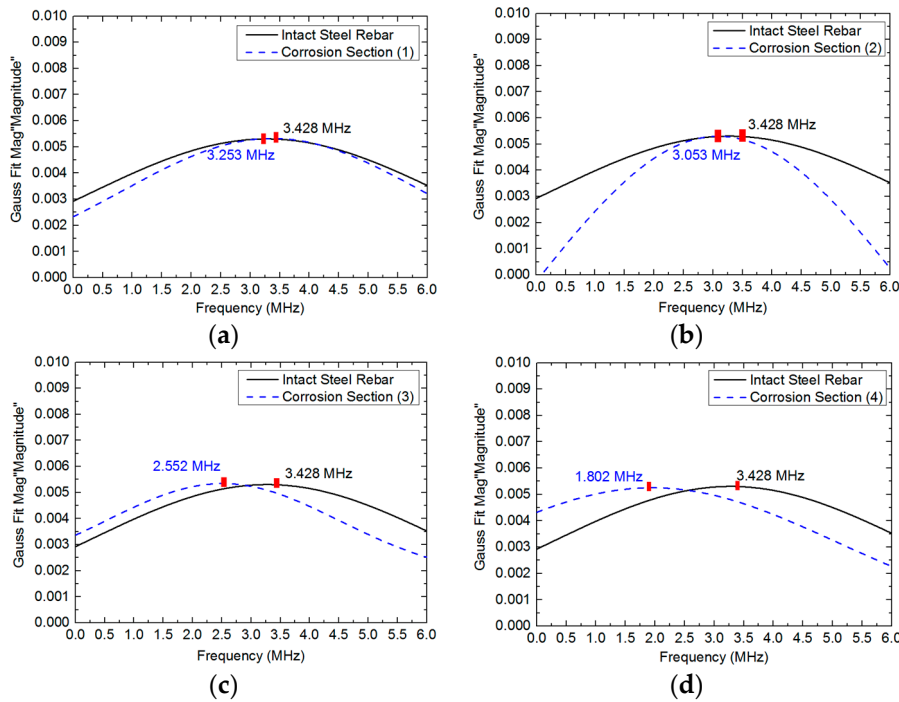
central frequencies were recorded according to the spraying frequency in each section. The curves of central frequencies at four different corrosion sections are presented in Figure 9. It can be observed that the frequency components made the attenuation from high to low due to the increase of micro-corrosion products. The reduction of central frequency was 0.175 MHz at section (1), 0.375 MHz at section (2), 0.876 MHz at section (3), and 1.626 MHz at section (4), which corresponds to the corrosion degree in different sections, respectively.

Figure 9. The frequency domain responses at four different corrosion sections on steel rebar after ACT.

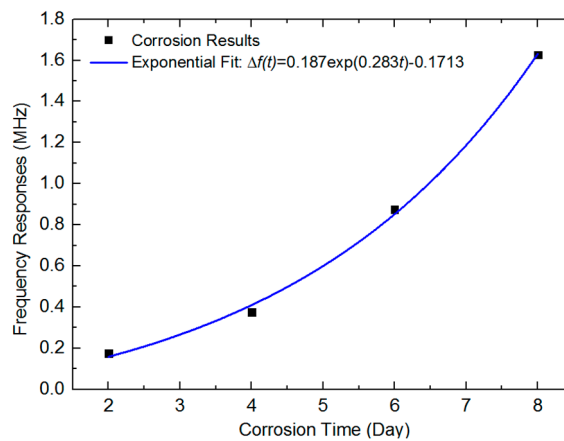
Combining the central frequency spectrum responses and corrosion time for each section, the trendline estimate is presented in Figure 10, which was fitted by using the exponential equation below:

$$\Delta f(t) = 0.187\exp(0.283t) - 0.1713, \tag{3}$$

where the Δf is the spectrum shift and the t is the corresponding corrosion time. The R-square was calculated as 0.99504 in exponential fit.

Figure 10. The frequency responses in four corrosion sections trendline estimates from corrosion time.

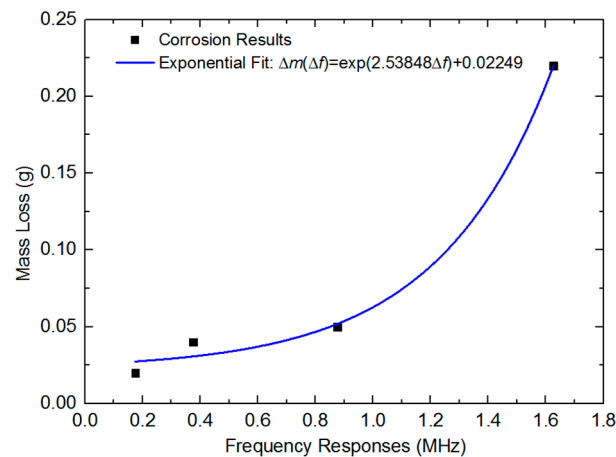
Combining the central frequency spectrum responses and the respective mass loss for each section, the trendline estimate is presented in Figure 11, which was fitted by using the exponential equation below:

$$\Delta m(\Delta f) = \exp(2.53848 \Delta f) + 0.02249, \quad (4)$$

where the Δm is the mass loss of rebar and the Δf is the corresponding spectrum shift. The R-square was calculated as 0.98306 in exponential fit. The central spectrum shifting was fitted as a perfect curve with the mass loss in exponential fit.

Figure 11. The mass loss of corrosion degree in four corrosion sections trendline estimates from frequency responses.
