**Detection and Quantification of Damage from ASR Gels
Using Multiphysical Nondestructive Evaluation**

SUBMITTED IN PARTIAL FULFILLMENT OF THE REQUIREMENTS
FOR THE DEGREE OF MASTER OF SCIENCE
DEPARTMENT OF CIVIL AND ENVIRONMENTAL ENGINEERING
UNIVERSITY OF MASSACHUSETTS LOWELL

Abstract

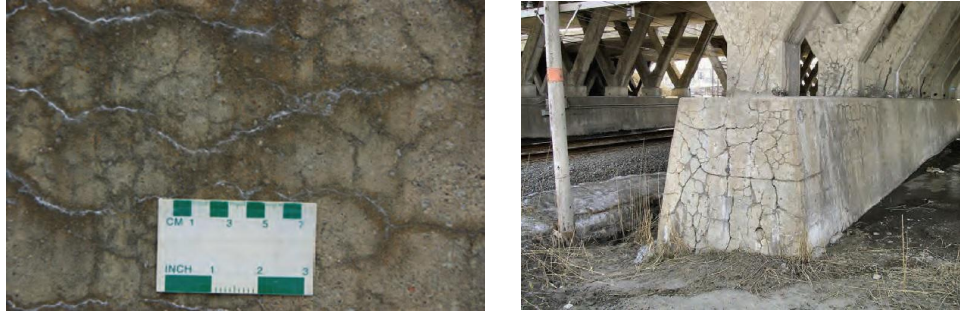
(a) Exudation of ASR gels from cracks (b) Severe cracking of bridge column

Figure 1-1: Examples of damage caused by ASR gels [1].

One form of deterioration in concrete structures is alkali-silica reaction (ASR). Through the monumental work of Stanton in 1940, it has been recognized as a major cause of damage in concrete structures due to the production of gels that expand upon the absorption of water [9]. An example of the extensive damage caused by ASR gels is shown in Fig. 1-1.

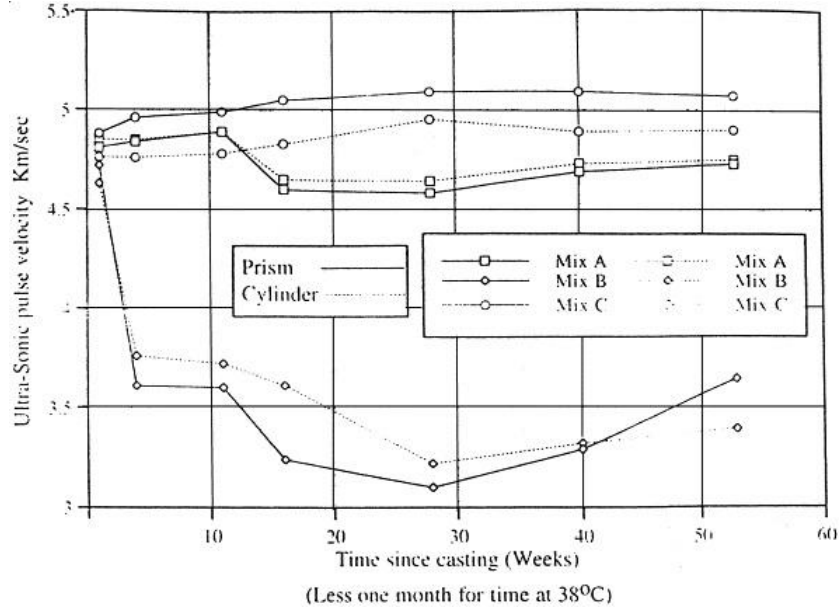
Figure 2-2: Variation of UPV of prisms (100 x 100 x 500 mm) and cylinders (150 x 300 mm) with time [3].

UT is one of the most popular NDE methods to date and it has seen much use in attempts to detect and quantify damage from ASR gels. Hobbs showed a decreasing trend in the UPV of concrete as both acid soluble alkali content and expansion percentages increase over the course of two years [17]. Even with larger specimens, the effects of ASR gels lowered UPV. Through two years of monitoring, Swamy demonstrated how UPV values in ASR-afflicted reinforced concrete beams are lower and more varying than those of an intact, control concrete specimen [51]. In addition, both Hobbs' and Swamy's research works examined UPV trends in correlation to the properties of ASR-induced cracks (e.g. maximum crack widths and first signs of cracking) [17, 52]. Ahmed *et al.* were able to record the progression of ASR damage using UPV. They found that concrete specimen made from aggregates prone to the reaction could experience a stage of initial damage followed by a recovery stage due to hydration [3]. The UPV for ASR-reactive specimens decreased initially due to cracks from the swelling of ASR gels; however, they either, for a short period of time, stabilized or even increased as cement hydration products and additional gels strengthened the specimen by filling the pores or cracks. Fig. 2-2 shows this phenomenon.

with a poor resolution since UPV varied from 3000 m/s to 5095 m/s while showing no consistent correlation with dynamic Young modulus which varied from 14.5 GPa to 36.4 GPa. Gong *et al.* expanded the analysis of UPV by using methods such as ultrasonic passband, attenuation spectrum, and stretching factor to detect and track ASR damage [35]. From these results, it is evident that UT is popular for the detection of damage from ASR gels.

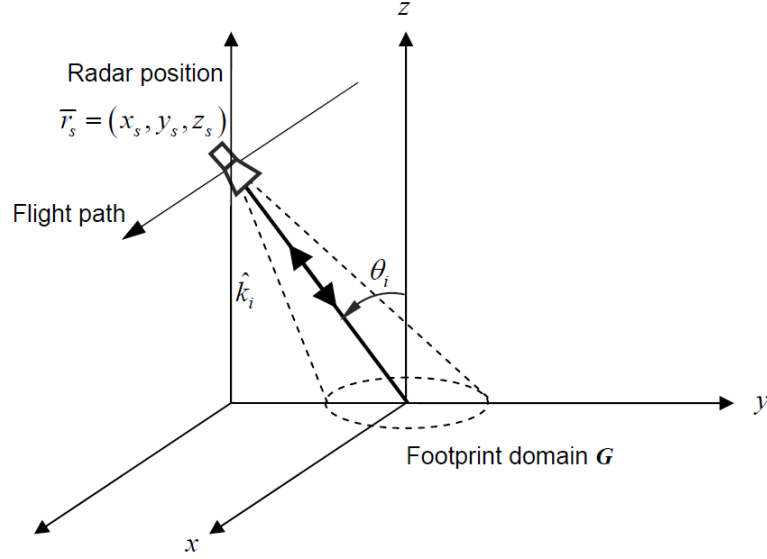
Figure 2-3: Stripmap synthetic aperture radar (SAR) travelling along a straight path aperture [4].

at $\bar{r}_s = (x_s, y_s, z_s)$ at a fixed height z_s and is moving at constant flight speed v . The incident wave is represented by a wave vector \hat{k}_i , the inclination angle with respect to the z axis is represented by θ_i , and the footprint domain is represented by G . Derivation of the time-independent SAR point response yields Eq. (2.3)

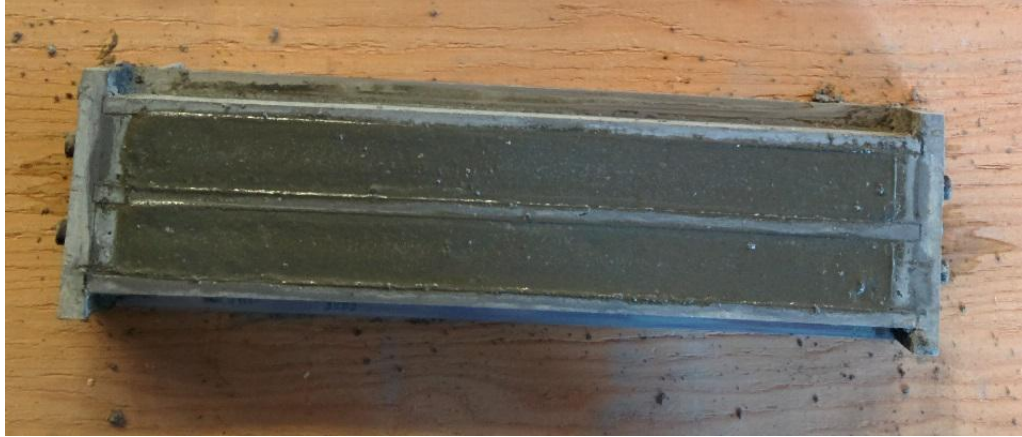
Figure 3-3: Cement mortar mix distributed into mold.

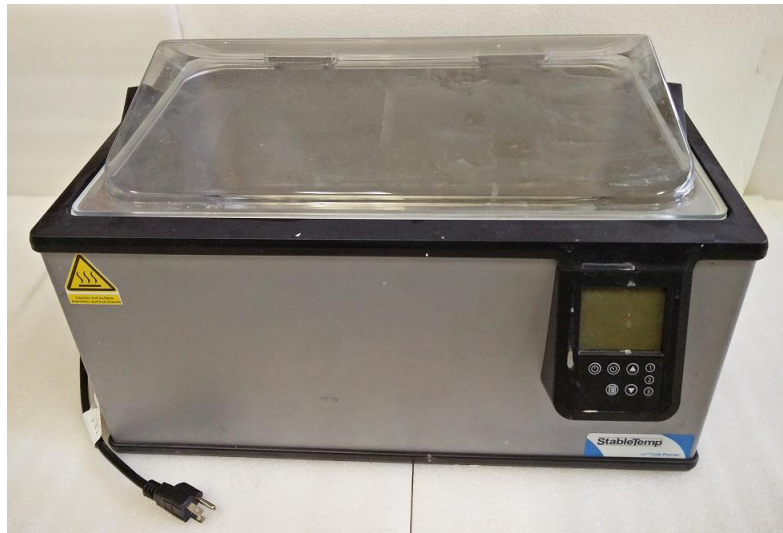
Figure 3-4: Water bath with custom temperature adjustments.

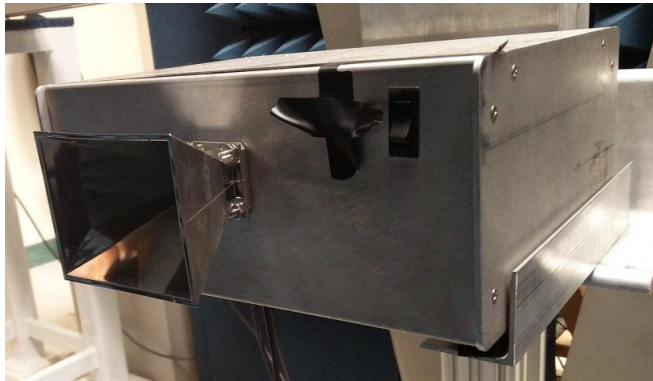
Figure 3-6: The microwave imaging radar instrument.

After the end of each time period of immersion in the 1N NaOH solution, the mortar bars were removed from the bath and left to dry for 15 minutes. They were subsequently taken to a separate lab for the SAR imaging scans using a continuous wave imaging radar (CWIR) system with a center frequency of 10 GHz, a bandwidth of 1.5 GHz, and HH polarization. This frequency was used due to the wavelength and cost of the antenna. An image of the radar instrument is provided in Fig. 3-6.

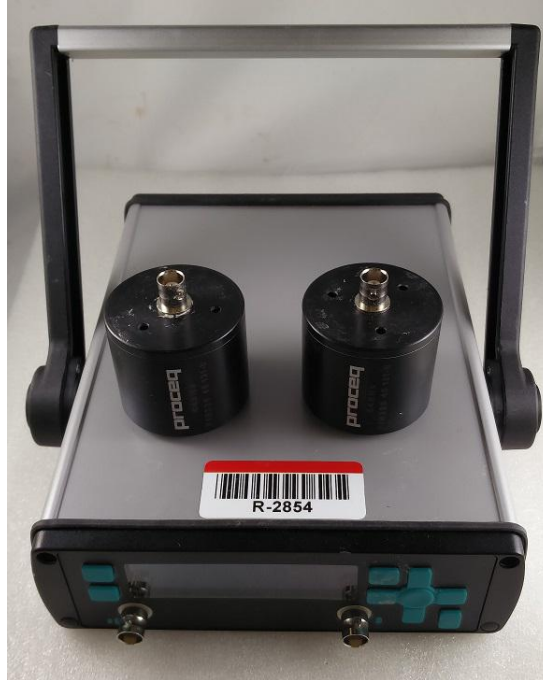
Figure 3-10: Proceq Pundit[®] Lab with 54 kHz frequency transducer pair.

Due to lack of availability, the tests were conducted with a 50 mm diameter transducer pair operating at 54 kHz frequency. An important note is that this frequency is much too low for the size of the mortar bars. The requirements for ASTM C597 "Standard Test Method for Pulse Velocity Through Concrete" were

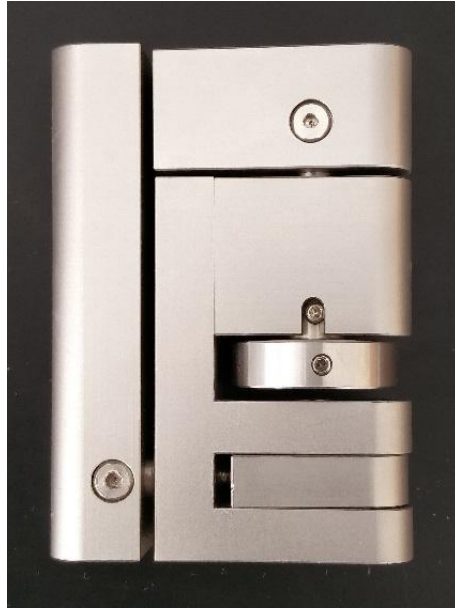
Figure 3-13: Shorting kit for calibration for dielectric measurement.

calibration were air, water, and a short kit shown in Fig. 3-13. The presence of three other sources of error were known to affect results: air gaps, cable stability, and environmental factors. Several measures were taken to accommodate for these possible sources of error. Measurements were performed in a relatively stable environment to eliminate additional interference from factors such as sudden changes in room temperature or relative humidity. In addition, gaps between the probe and surface were visually inspected to ensure there was as close of a perfect contact as possible. Locations on the surface of the mortar bar that exhibited significant cracking were avoided to prevent the influence of air on the measurements. The cable was also allowed to stabilize and was prevented from flexing as measurements were made. These measurements were conducted on five locations of each mortar bar. The points of contact were situated on the smoother underside of the mortar bars, opposite from the front surface exposed to air during

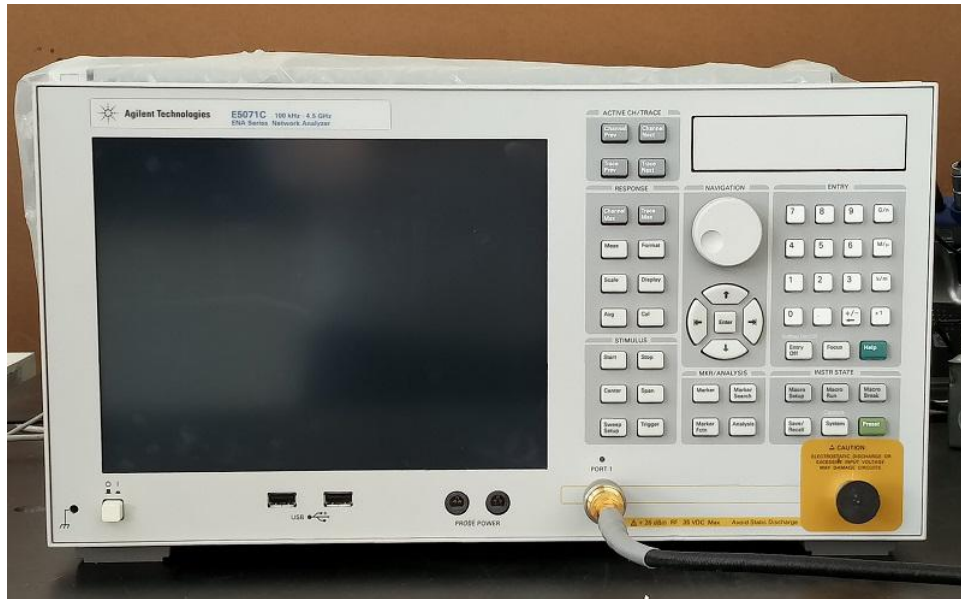
Figure 3-14: E5071C Agilent® ENA Series Network Analyzer.

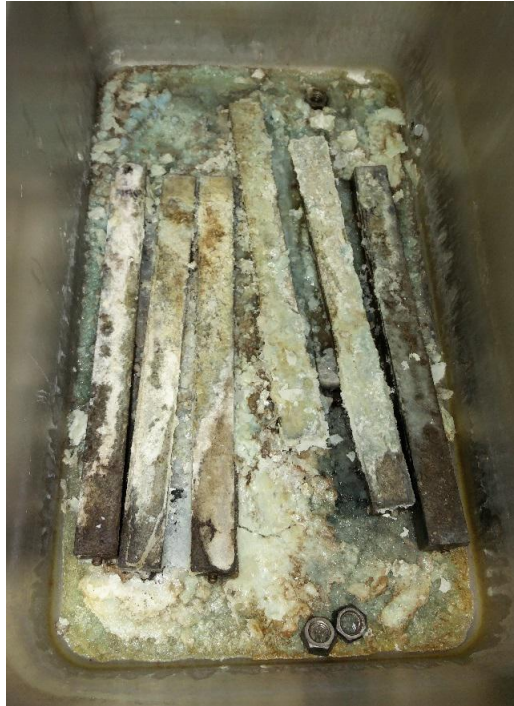
Figure 3-16: ASR gels leached out of mortar bars.

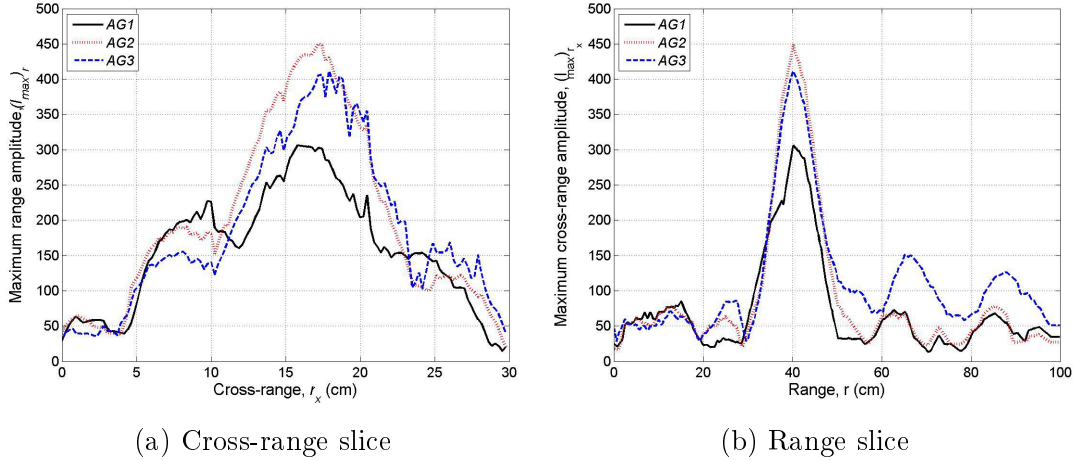
Figure 4-4: 28-day, *MB1* maximum amplitude slices.

For nearly all range and cross-range amplitude slices for mortar bars scanned vertically and stored in the NaOH solution for 14 days and beyond, each peak of the mortar bars made from the reactive aggregates was greater than that of the *AG1* mortar bars made from the nonreactive aggregate. The only exception came

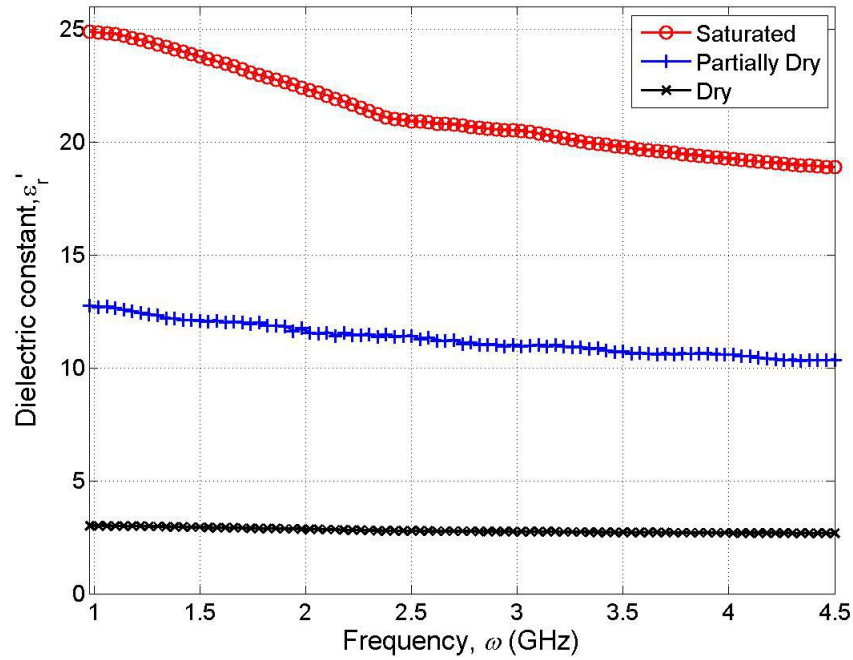
Figure 4-17: Dielectric constants of ASR gels.

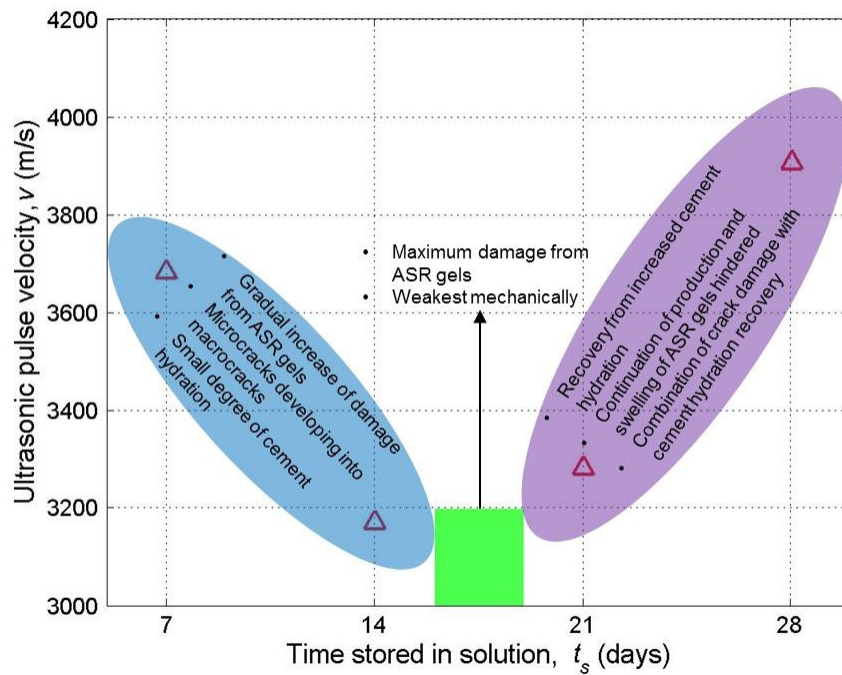
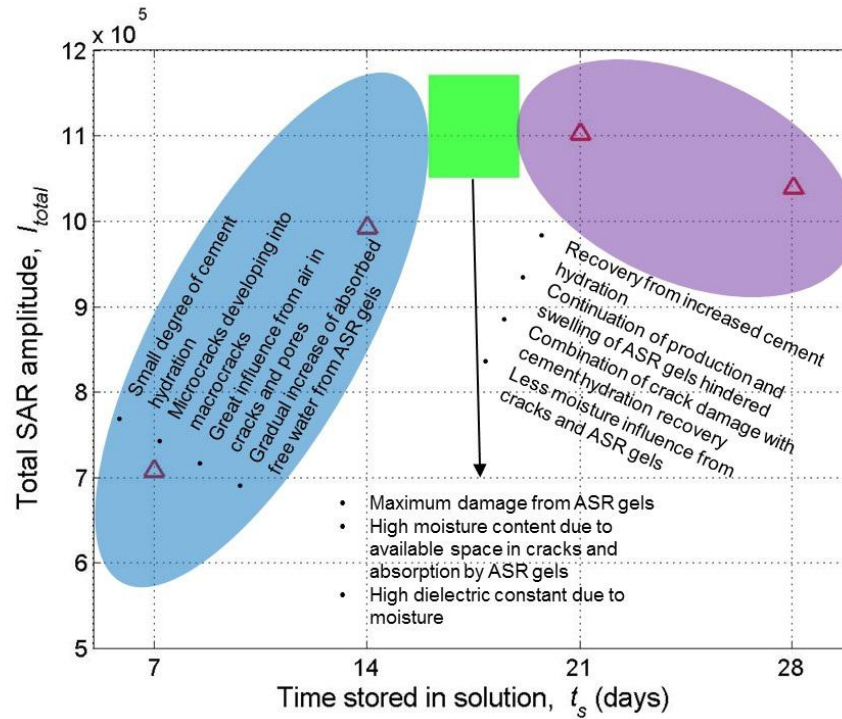
(a) Ultrasonic pulse velocity

(b) Total SAR amplitude

(c) Dielectric constant

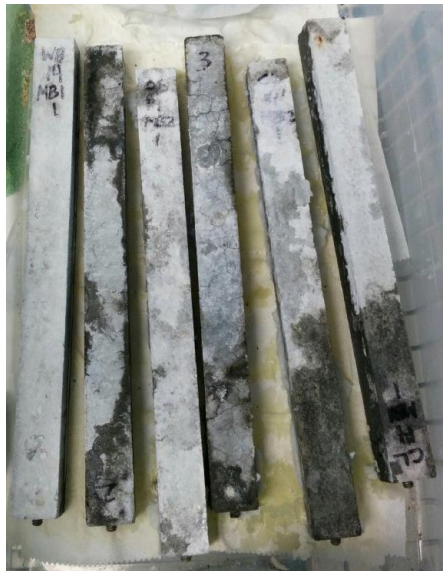
Figure A-2: 14-day mortar bars (left to right - *AG3 MB1*, *AG3 MB2*, *AG2 MB2*, *AG2 MB1*, *AG1 MB2*, *AG1 MB1*).
